Mount Climie 730 antenna pole RF Earth install and testing
by John M. Wysocki ZL2TWS

An independent RF earth has been commissioned for the 730 north antenna aluminium pole. Two sets of commercially manufactured 4 dipole stacks have all failed resulting in crackle and noise on 730.

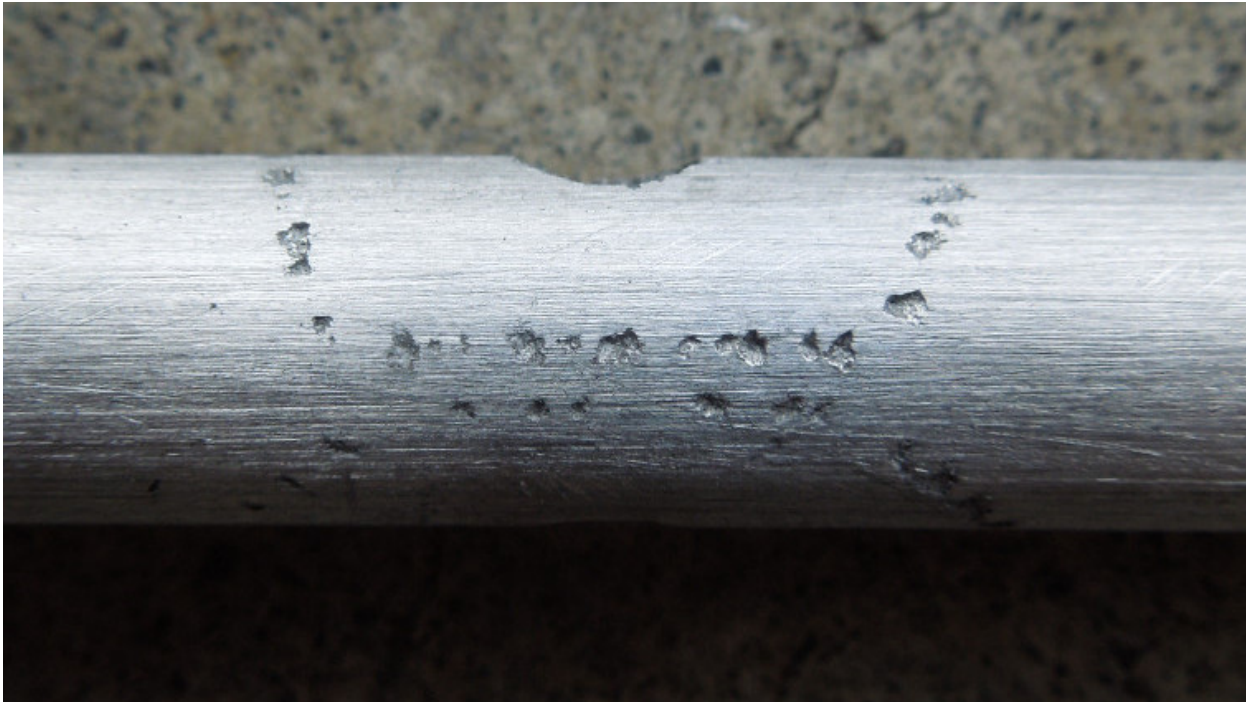
Electrolysis corrosion is also seen at dipole joints. This indicates current flowing at the RF neutral potential connection to the horizontal mounting boom seen in Picture-2.

Picture-2: Dipole to boom corrosion pitting.

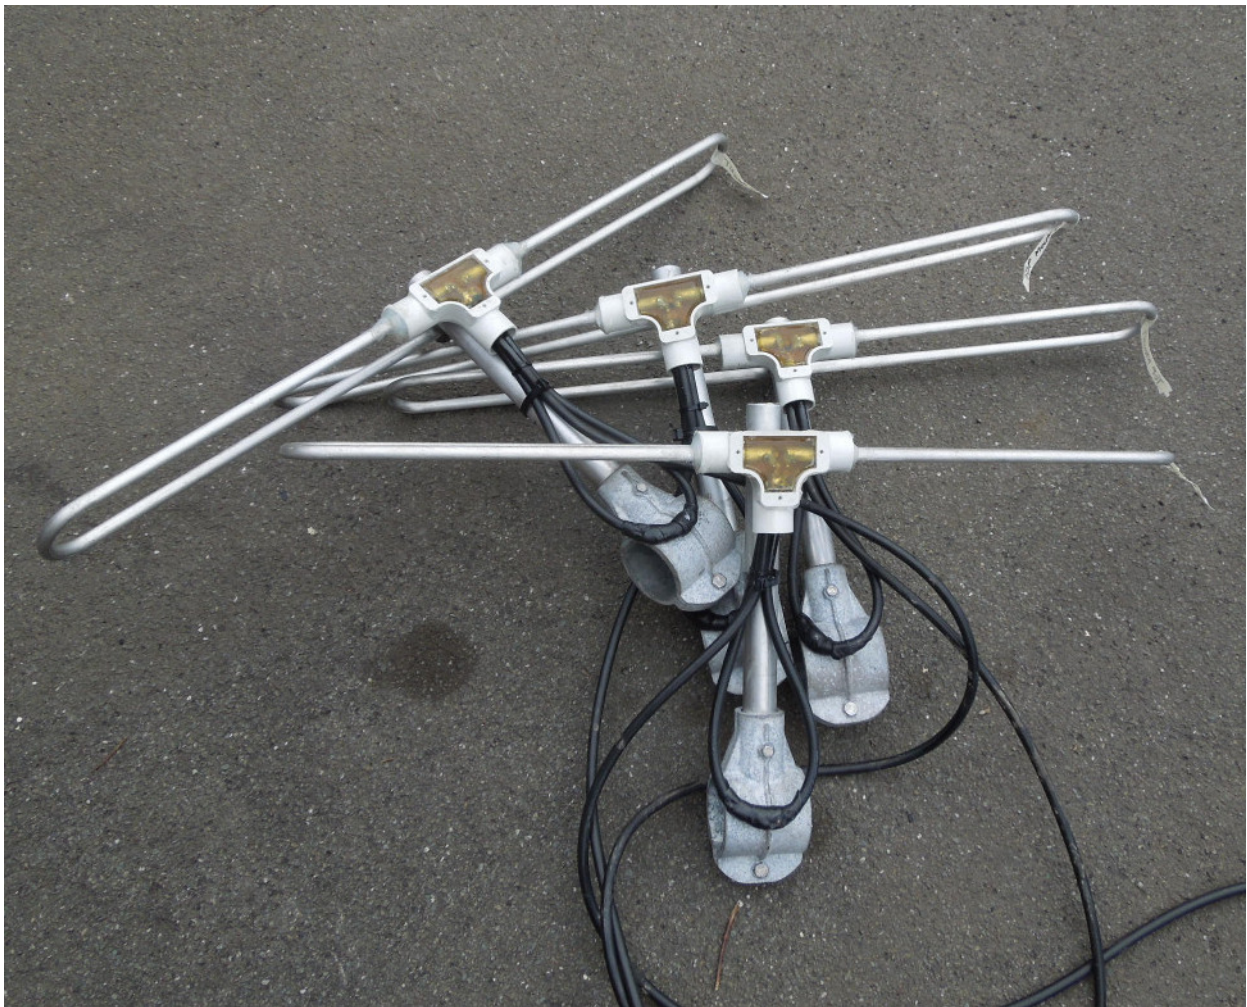
Picture-3: Rebuilt dipole set.

New traditional 4:1 coaxial baluns have been made and epoxy filled connections boxes without braid grounding were made as seen in Picture-3. Braid grounding is now done via a lightning arrester and individual earth stake. Picture-5.

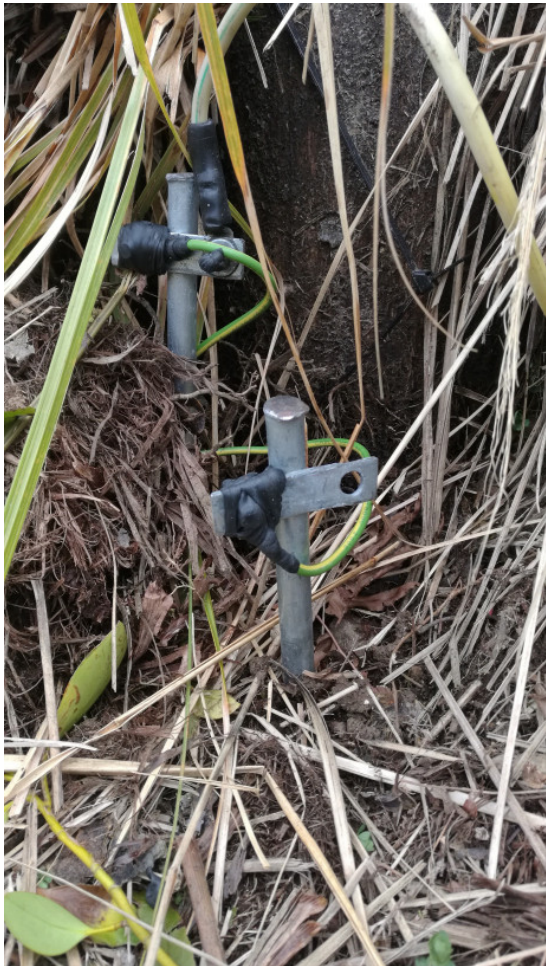
The earth loop impedance should read better than 200 ohms as an internationally accepted value. Our test is 106 ohms when the stakes were driven. This is expected to go lower in wet conditions and be high during the summer. The south hut AC earth is 0.6 ohms and North hut sub main is 0.8 ohms.

Picture-4: Earth stakes in parallel 29th September 2019.

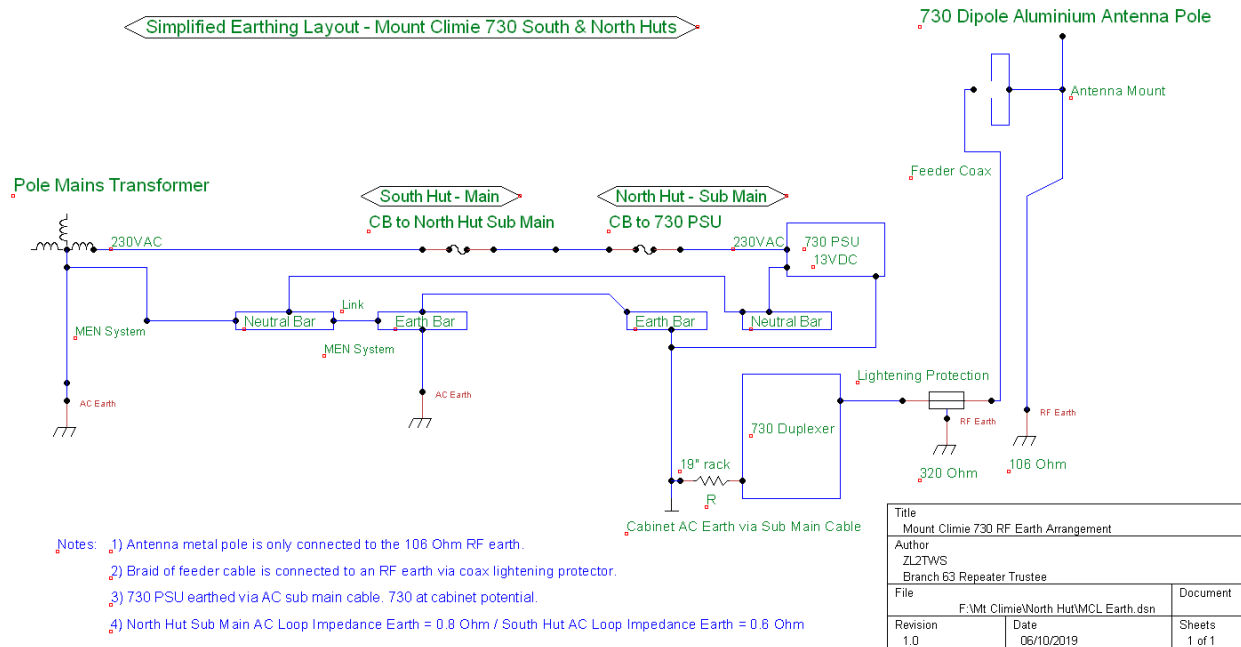
Picture-5: Shows the test arrangement at Climie.

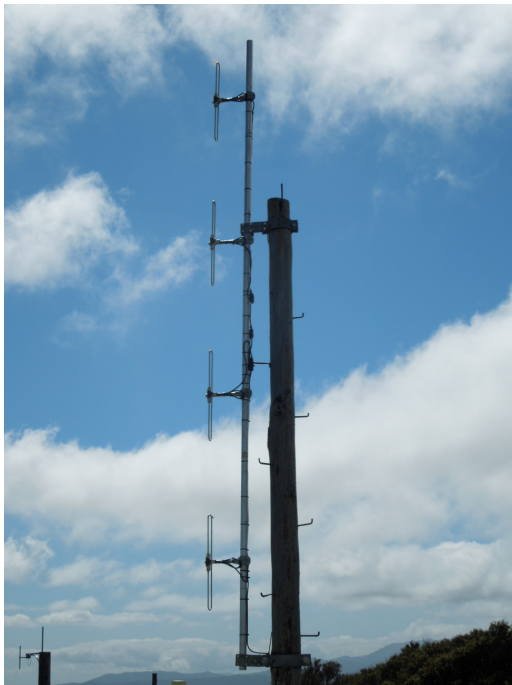
Picture-6: New 730 antenna stack 6th October 2019.
