# QST63

## ZL2VH Newsletter – July 2025

# **VHF Twin Dipole Antenna Combiner and tuning stub for 730 Mount**

**Climie by John M. Wysocki ZL2TWS**

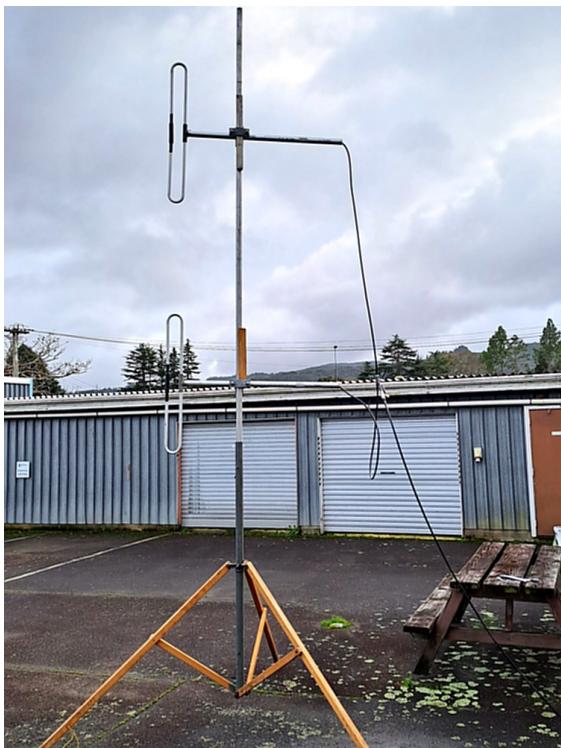
The following pictures below show the dipole test tripod and separation/spacing when combined. A picture of the combiner and stub tuner ready for installation at Climie. Reference 1) Shows the matching section and tuned stub details.

In free space Dipoles combined on tripod. 123 mm matching section and side mounted 105 mm stub.

**Note:** Stub length depends on connector choice.

This article points out that the antenna cables present 50-ohms to the combiner (25-ohms combined). The 123 mm matching section (connector tip to tip) and stub then transform the impedance back up to 50-ohms. The matching section and stub coax is high quality RG-213. The open circuit stub

coax length from open end to the centre solder pin of the elbow connector is 105 mm.
